10.1002/2015WR017426

Evidence of an emerging levee failure mechanism causing disastrous floods in Italy

Stefano Orlandini¹, Giovanni Moretti¹, and John D. Albertson²

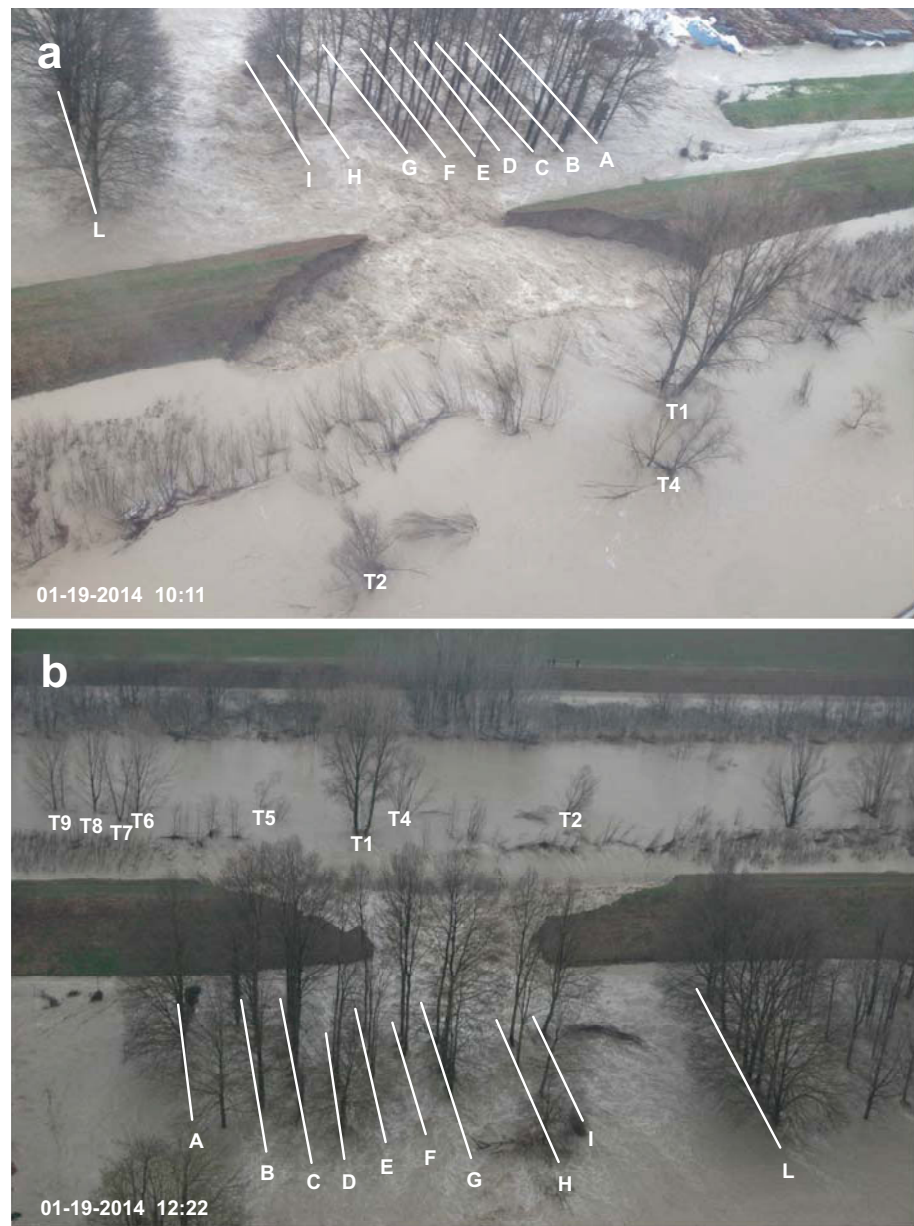
The breach that occurred along the Secchia River on 19 January 2014 (Figures 1 and 4) was first detected at 6:30. It has been reported by several observers that the breach developed from above and that a large erosive flow was spilling out from the river to the landside bank of the levee at the time of the detection. Given

Figure 4. Photographs of the breach formed along the Secchia River at San Matteo taken from helicopters at 10:11 (Figure 4a) and 12:22 (Figure 4b) of 19 January 2014. Relevant geometrical features of the land surface close to the breach (trees T1–T9 in the riverbed and tree rows A–L in the landside plain) are identified on the photographs to allow the breach configuration to be georeferenced and transferred to relevant aerial photographs (Figures 5b and 5c).

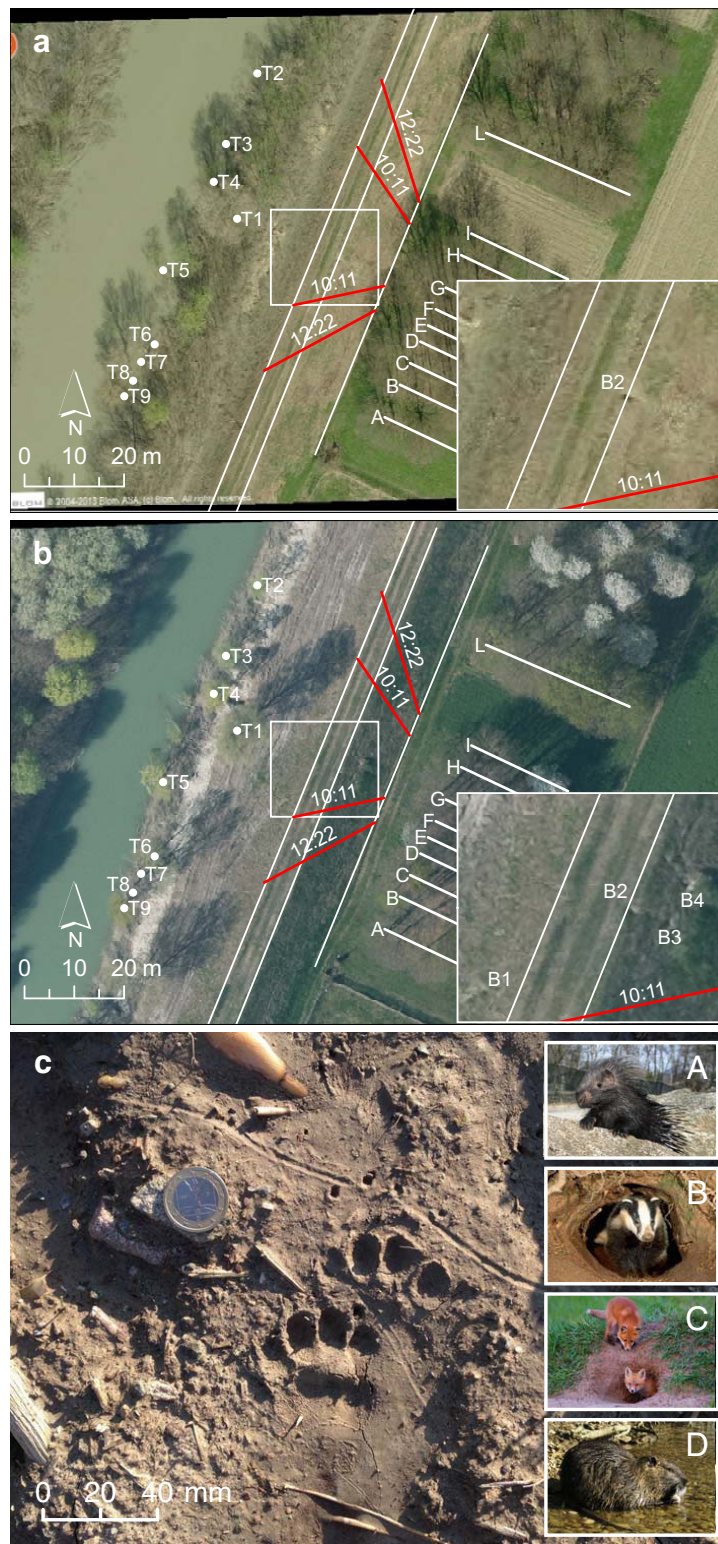
Evidence of wildlife impact on the failed levee was derived from the analysis of 10 cm resolution aerial photographs taken in 2010 and 2012 (Figures 5a and 5b, respectively). This evidence was confirmed by field inspection of the Secchia River after the disaster (Figure 5c). More generally, extensive field inspection conducted along the Secchia and Panaro Rivers revealed an emergent risk connected to the activity of crested porcupines *Hystrix cristata* (Linnaeus, 1758), European badgers *Meles meles* (Linnaeus, 1758), red foxes *Vulpes vulpes* (Linnaeus, 1758), and nutria *Myocastor coypus* (Molina, 1758) (insets A, B, C, and D, respectively, in Figure 5c). The information of the photographs taken from helicopters in the early stage of breach development, at 10:11 and 12:22 (Figure 4), and of previously taken aerial photographs (Figures 5a and 5b) were combined to determine the precise location of the levee where the failure mechanism originated (section A2). Animal burrows (B1, B2, B3, and B4) were found to exist in the levee location where the breach originated (Figures 5a and 5b). In addition, terrain analysis based on a 1 m resolution digital elevation model (DEM) generated from a lidar survey revealed the positions of the animal burrows observed in Figure 5b along the cross section of the failed levee (section A2). Results are reported in Figure 6.

Figure 5. Evidence of burrowing animals in the location of the Secchia River levee that failed on 19 January 2014. Long parallel lines mark the top and landside bottom boundaries of the levee. Figure 5a shows animal burrows appearing in the 10 cm resolution aerial photography taken on 27 March 2010. Figure 5b indicates that on 29 March 2012, animal burrows were further developed. Figure 5c shows the footprint of a wild animal (probably a badger or a crested porcupine) observed on 24 February 2014, along the repaired levee. The burrowing animals that have impacted the levees of the Secchia River include those shown in the insets of Figure 5c: (a) crested porcupine *Hystrix cristata* (Linnaeus, 1758), (b) European badger *Meles meles* (Linnaeus, 1758), (c) red fox *Vulpes vulpes* (Linnaeus, 1758), and (d) nutria *Myocastor coypus* (Molina, 1758).

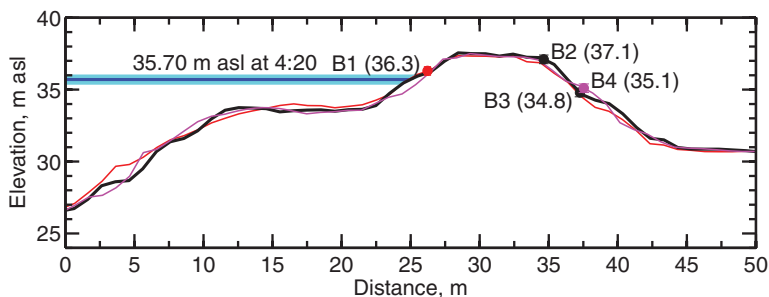
Figure 6. Geometrical relationship between the elevations of burrows B1, B2, B3, and B4 observed (in 2010 and 2012) in aerial photographs (Figures 5a and 5b) of the Secchia River at San Matteo and the river stage reconstructed from hydraulic modeling for the same levee location on 19 January 2014 at 4:20 (Figure 3). Direct river inflow into the den system can be considered possible if an uncertainty of 0.3 m in the determination of both burrow elevations (uncertainty bars) and river stages (light blue band) is acknowledged (hypothesis 1 and section 4.1).

row located on the riverside of the levee (36.3 ± 0.3 m asl) at 4:20, when the river stage was estimated to be 35.70 ± 0.30 m asl (Figures 3b and 6). Since it can be clearly observed that the system of dens developed significantly from 2010 (Figure 5a) to 2012 (Figure 5b), and burrowing animals like badgers or crested porcupines were still living along the repaired levee in 2014 (Figure 5c), it is likely that the den system was more developed at the time of the levee failure than shown in the photograph taken in 2012 (Figure 5b). This would further support the triggering of internal flow and erosion processes by direct river inflow into the riverside entrance of the den system.

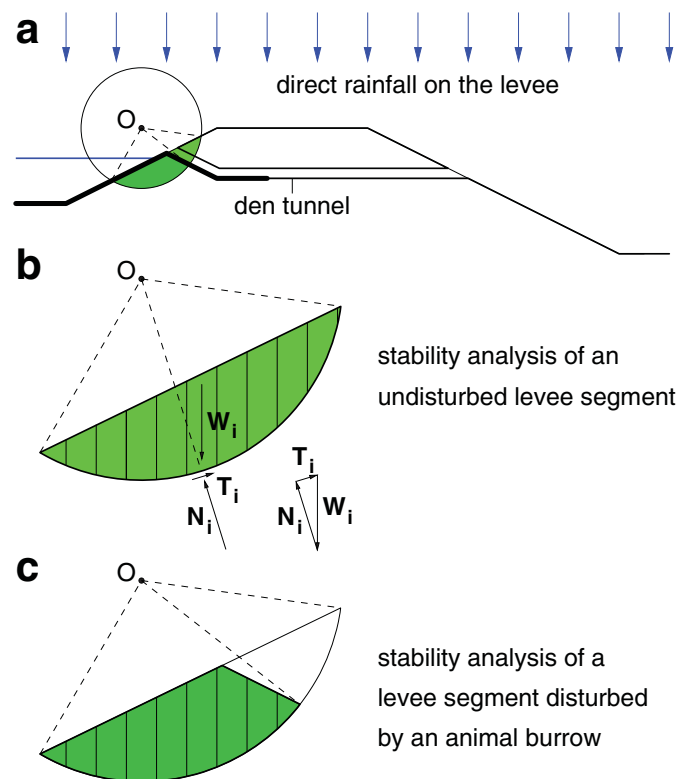
Figure 8. Sketch of the slope stability analysis performed to assess the impact of animal burrows on equilibrium conditions (hypothesis 2 and section 4.2). The bold line in Figure 8a indicates the levee portion on which the analysis focuses. The equilibrium of green segments shown in Figures 8b and 8c is evaluated: O is the center of the circular sliding surface, W_i is the weight of the i th element composing the sliding segment, T_i and N_i are the shear and normal components of W_i to the sliding surface. The blue vertical arrows indicate the direct rainfall on the levee. The blue horizontal line indicates the river stage. The two cases in which the animal burrow is not present (Figure 8b) or is present (Figure 8c) are considered.

A Fellenius slope stability analysis was then performed by varying the center of the circular sliding surface and considering all the forces acting on the variably saturated sliding soil segment (section A4). It is important to note that this was a simplified 2-D stability analysis, and as such the results should be both meaningful for evaluating hypothesis 2 and on the conservative side. The results are reported in Figure 9. A first set of numerical experiments reveals that no instabilities occur by considering a realistic configuration of the tunnel extending from the riverside den entrance into the levee (Figures 9a–9c). No red lines indicating critical sliding surfaces are shown in Figures 9d–9f. The (unknown) internal tunnel geometry is varied in the second set of numerical experiments until red lines indicating critical sliding surfaces came out (Figures 9g–9i). These critical geometrical settings are, however, found to be unrealistic because they produce levee failures also in times when no failures were observed to occur (Figures 9j–9l).

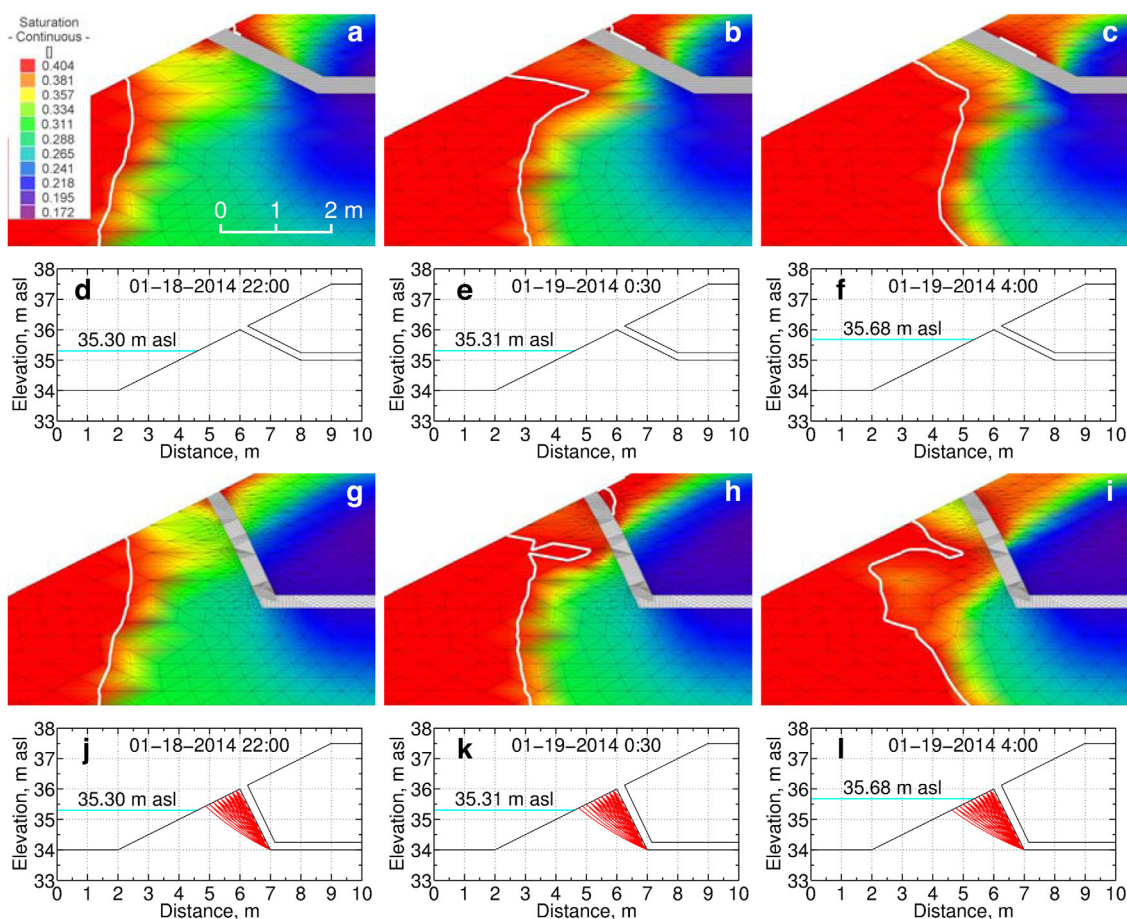
Figure 9. Simulated response of the levee of the Secchia River at San Matteo to direct rainfall on the levee (Figure 2b) and river stage (Figure 3b) in the case sketched in Figure 8 (hypothesis 2). Two possible hypothetical configurations for the tunnel extending from the riverside animal burrow into the levee are reported in Figures 9a–9f and 9g–9l, respectively. The simulation period started at time 22 December 2013 at 0:00 to mitigate the memory effects on the reconstructed levee status. The reconstructed fields of volumetric soil water content are reported at times 18 January 2014 at 22:00 (Figures 9a, 9d, 9g, and 9j), 19 January 2014 at 0:30 (Figures 9b, 9e, 9h, and 9k), and 19 January 2014 at 4:00 (Figures 9c, 9f, 9i, and 9l). The term “saturation” reported in the legend of Figure 9a is used in the FEFLOW program to denote the volumetric soil water content. The white line in Figures 9a–9c and 11g–11i denotes the phreatic (zero pressure) surface.

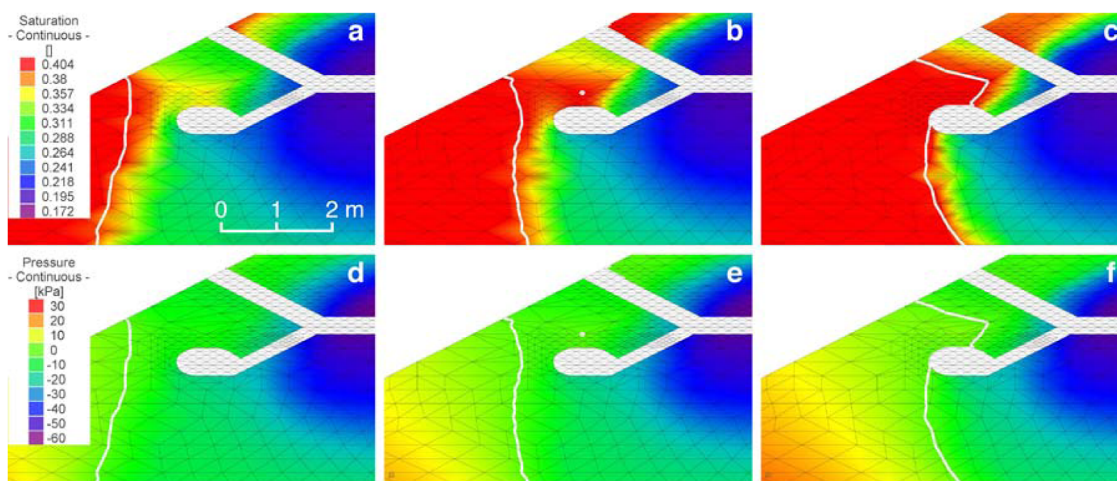
pressure (Figures 11d–11f) become critical at 4:00 of the day 19 January 2014 (Figures 11c and 11f), and that these critical conditions do not occur in other times of the simulation period (December 2013 and January 2014) as should be expected (e.g., Figures 11a–11c and 11f). At 4:00 of 19 January 2014, the ceiling of the chamber became saturated and the soil water pressure became positive. This occurrence would have likely implied the collapse of the den system and the triggering of internal flow and erosion, even with the elevations of animal burrows observed in 2012 (section A5).

Figure 11. Simulated response of the levee of the Secchia River at San Matteo to direct rainfall on the levee (Figure 2b) and river stage (Figure 3b) in the case sketched in Figure 10 (hypothesis 3). The simulation period started at time 22 December 2013 at 0:00 to mitigate memory effects on the reconstructed levee status. The reconstructed fields of volumetric soil water content and pressure are reported at times 18 January 2014 at 22:00 (Figures 11a and 11d), 19 January 2014 at 0:30 (Figures 11b and 11e), and 19 January 2014 at 4:00 (Figures 11c and 11f). The term “saturation” reported in the legend of Figure 11a is used in the FEFLOW program to denote the volumetric soil water content. The white line denotes the phreatic (zero pressure) surface.
