10.1002/2015WR017426

Evidence of an emerging levee failure mechanism causing disastrous floods in Italy

Stefano Orlandini¹, Giovanni Moretti¹, and John D. Albertson²

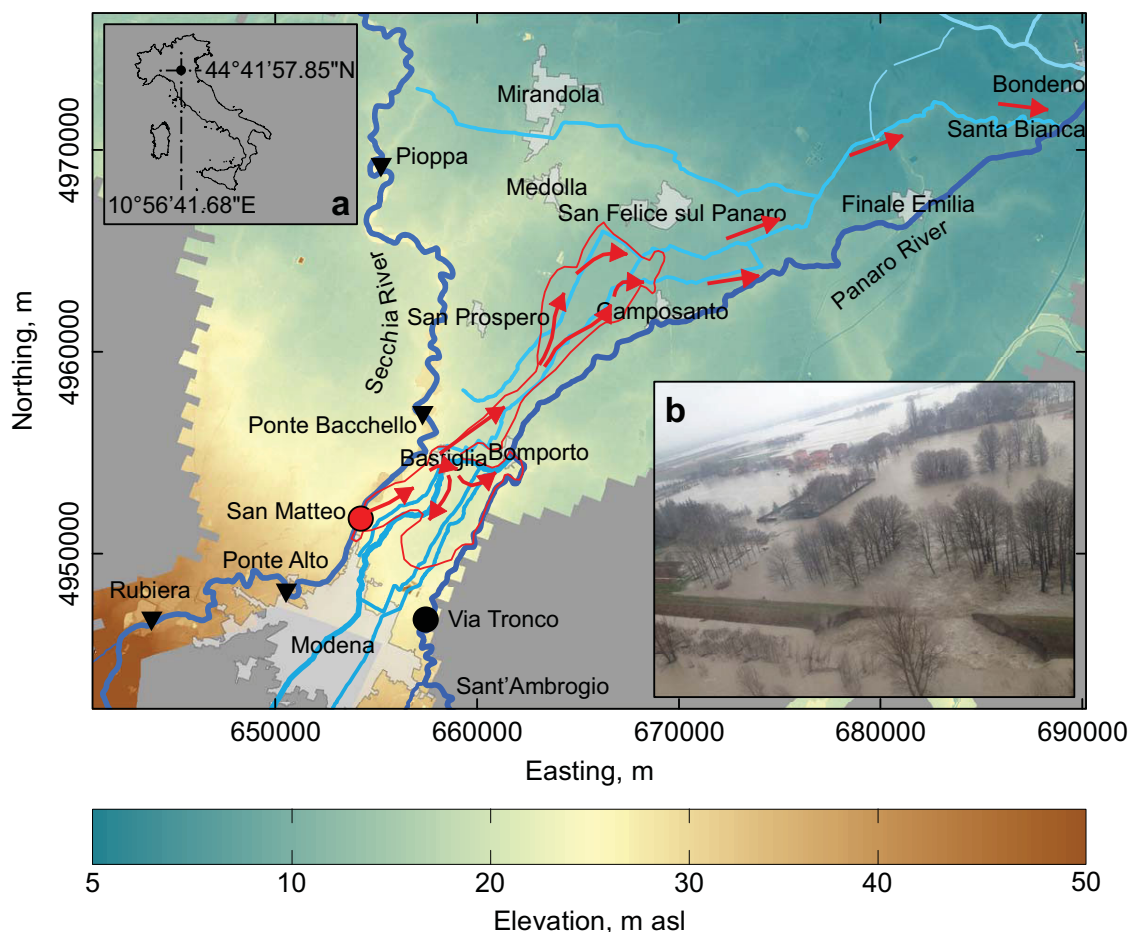
On 19 January 2014, a levee failure occurred along the Secchia River at San Matteo, Northern Italy ($44^{\circ}41'57.85''\text{N}$, $10^{\circ}56'41.68''\text{E}$, Figure 1a). The breach formed on the right side of the river system (from the perspective of looking downstream) was first observed in the morning around 6:30. Since a rapid repair was impracticable at that time, the breach developed by releasing to the surrounding plain a water volume of about $36 \times 10^6 \text{ m}^3$ with a peak flow discharge of about $434 \text{ m}^3 \text{ s}^{-1}$ (section A1). The ultimate extent of the flooded area was about 52 km^2 and the estimated flooding damage was in excess of \$500 million (Figure 1). The levees of the Secchia River are, at least in the perspective of the present investigation, representative of the levee systems developed in the Po Valley from the sixteenth century and now extending for about 2300 km (levees on both sides of the river) along the Po River and its tributaries. The Po Valley is the most densely populated and economically developed area in Italy.

Figure 1. (a) Map of the land flooded after the levee failure occurred along the Secchia River at San Matteo (Northern Italy) on 19 January 2014. (b) The delineation of the flooded areas is based on aerial surveys carried out by the Civil Protection as part of the emergency response plan for the occurred disaster. A volume of water of about $36 \times 10^6 \text{ m}^3$ (Figure 3a, area under the breach loss hydrograph) left the Secchia River by flooding (red arrows) an area of about 52 km^2 . Topographic gradients and barriers are shown by the 1 m resolution digital elevation model reported in the background.

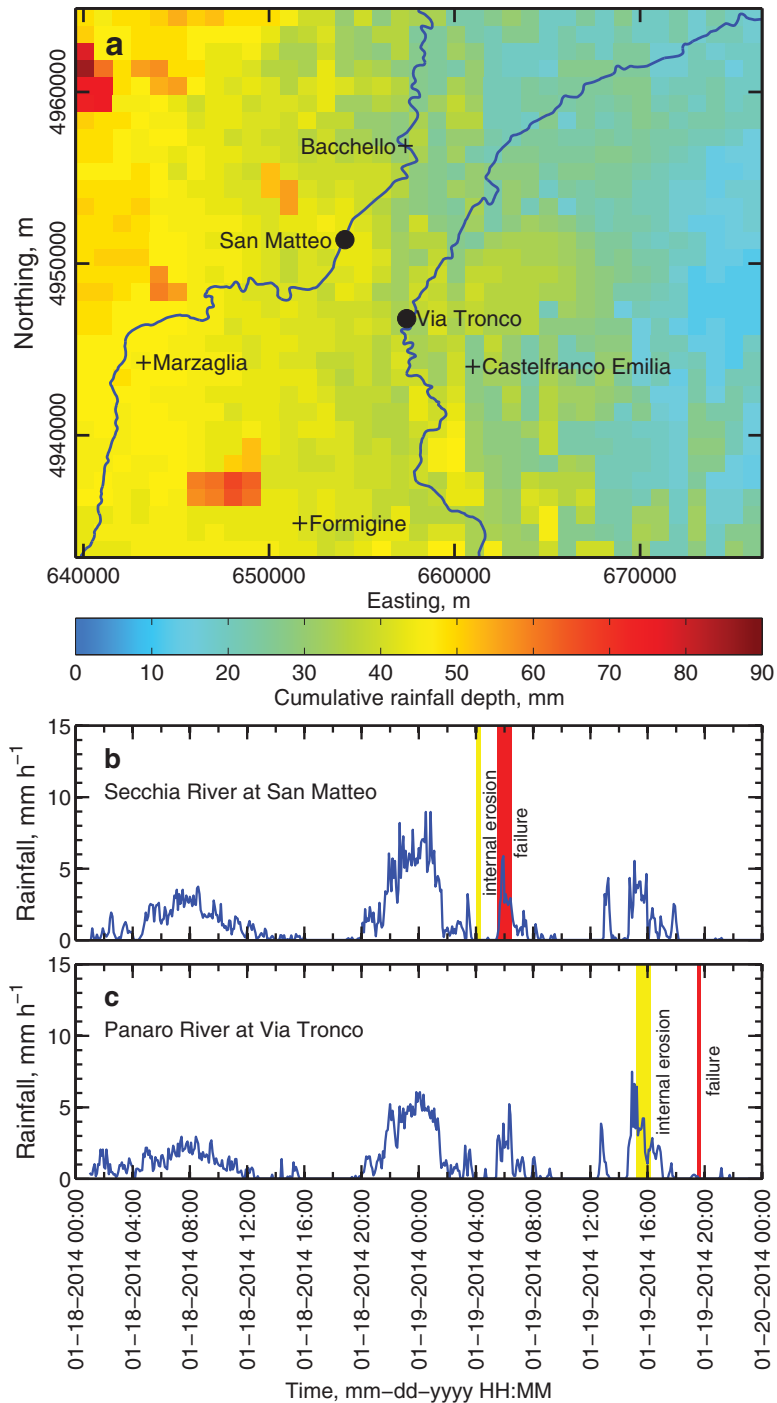
Figure 2. Rainfall occurred along the Secchia and Panaro Rivers in the period of time from 18 January 2014 at 2:00 to 19 January 2014 at 2:00. A radar image at 1 km × 1 km spatial resolution of the cumulative rainfall depth is shown in Figure 2a. The hyetographs extracted from radar images at 5 min temporal resolution, for the locations of the levee failures occurred along the Secchia River at San Matteo and the Panaro River at Via Tronco, are shown in Figures 2b and 2c, respectively. The estimated times at which the internal erosion was triggered and levee failure occurred are indicated in Figures 2b and 2c by the yellow and red bands, respectively.

First, the hydroclimatic conditions were very similar in the two cases, with both the failed levees directly wetted by vertical infiltration from local convective rainfall during the transit of the flood wave (Figure 2). Second, high river stages were reconstructed or observed to occur in both the river systems before the levee failures, but these stages were significantly below the top of the levees, so that overtopping of the original levee top can be excluded. Thirdly, in both the cases, dens of burrowing animals were found to exist in the locations in which the levees failed (Figures 5 and 7). In addition, other possible causes of levee failure were evaluated and found, in the cases of the considered levee structures and hydroclimatic events, to be significantly less plausible than a levee failure induced by burrowing animals [D’Alpaos *et al.*, 2014]. In any case, the event observed along the Panaro River and documented in Figure 7 provides clear evidence of this levee failure mechanism caused by burrowing animals. This is examined mechanistically below.

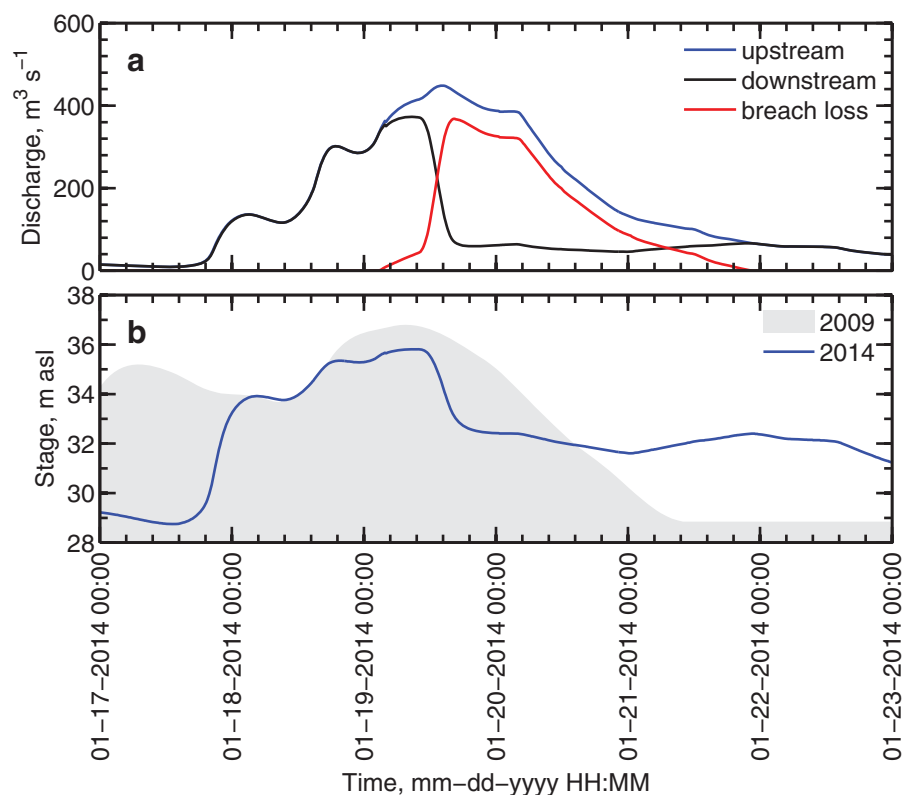
The flood hydrographs from December 2013 and January 2014 at the cross section of the failed levee were reconstructed by developing a level pool routing model and a dynamic wave model (section A1). Reconstructed flow discharge and river stage for the period 17–22 January 2014 are reported in Figures 3a and 3b, respectively. The breach flow loss was computed by incorporating into the dynamic wave model an explicit description of the breach evolution, obtained from photographs taken during the event (Figure 4). The combined use of observations and models yielded the results reported in Figure 3, revealing that (1) the maximum stage reached by the river flow in January 2014 was about 1.5 m below the top of the levee and (2) the magnitude of the peak river stage and the duration of high river stages along the Secchia River in January 2014 were smaller than the corresponding quantities observed in previous events such as, for instance, those observed in December 2009 (Figure 3b).

Figure 3. Reconstructed flow discharges (Figure 3a) and river stages (Figure 3b) at the cross section of the Secchia River at San Matteo where the levee failure occurred. A longer simulation period (from 22 December 2013 at 0:00 to 3 February 2014 at 24:00) than that reported in Figures 3a and 3b was considered to provide a sound analysis of the hydraulic response of the levee to the river stage forcing. The flood hydrograph occurred in December 2009 (from 23 December 2009 at 14:00 to 28 December 2009 at 14:00) is reported in the background of Figure 3b to enable a visual comparison.

row located on the riverside of the levee (36.3 ± 0.3 m asl) at 4:20, when the river stage was estimated to be 35.70 ± 0.30 m asl (Figures 3b and 6). Since it can be clearly observed that the system of dens developed significantly from 2010 (Figure 5a) to 2012 (Figure 5b), and burrowing animals like badgers or crested porcupines were still living along the repaired levee in 2014 (Figure 5c), it is likely that the den system was more developed at the time of the levee failure than shown in the photograph taken in 2012 (Figure 5b). This would further support the triggering of internal flow and erosion processes by direct river inflow into the riverside entrance of the den system.
